# **Soil Contamination Assessment: Paardevlei BESS Project**

**Report Number 600617/01**

**November 2023**

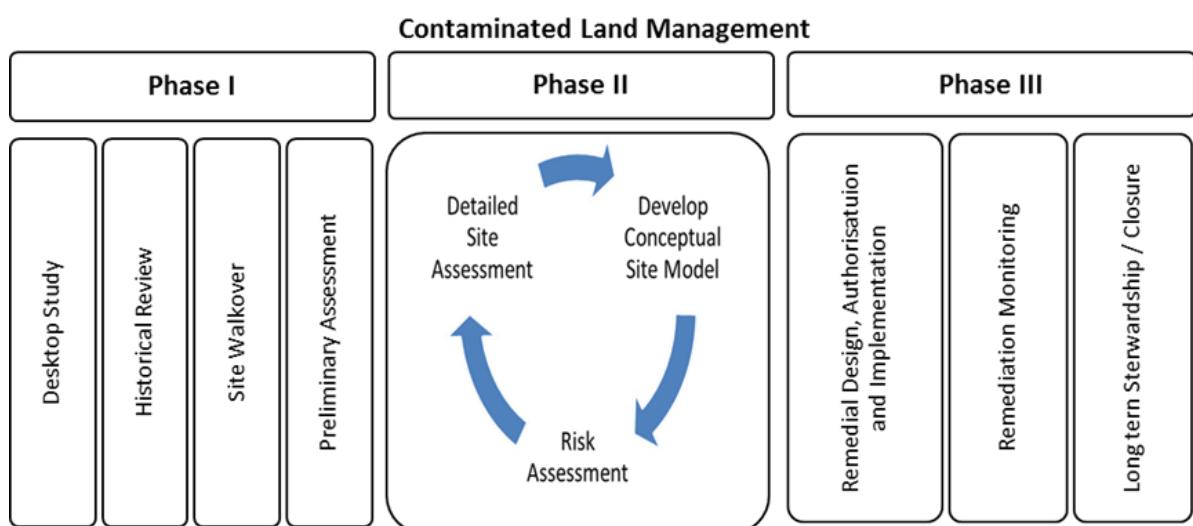
**Figure 2-2 : Generic Contaminated Land Management Process**

The approach followed in this contaminated land assessment is illustrated in Figure 2-2. This approach is in accordance with the “Norms and Standards for the assessment and remediation of Contaminated Land” as envisioned in Part 8 of the NWM:WA, and by reviewing international best practices. The principles and guidelines of the international best practices have been adapted, where required, to suit South African conditions.

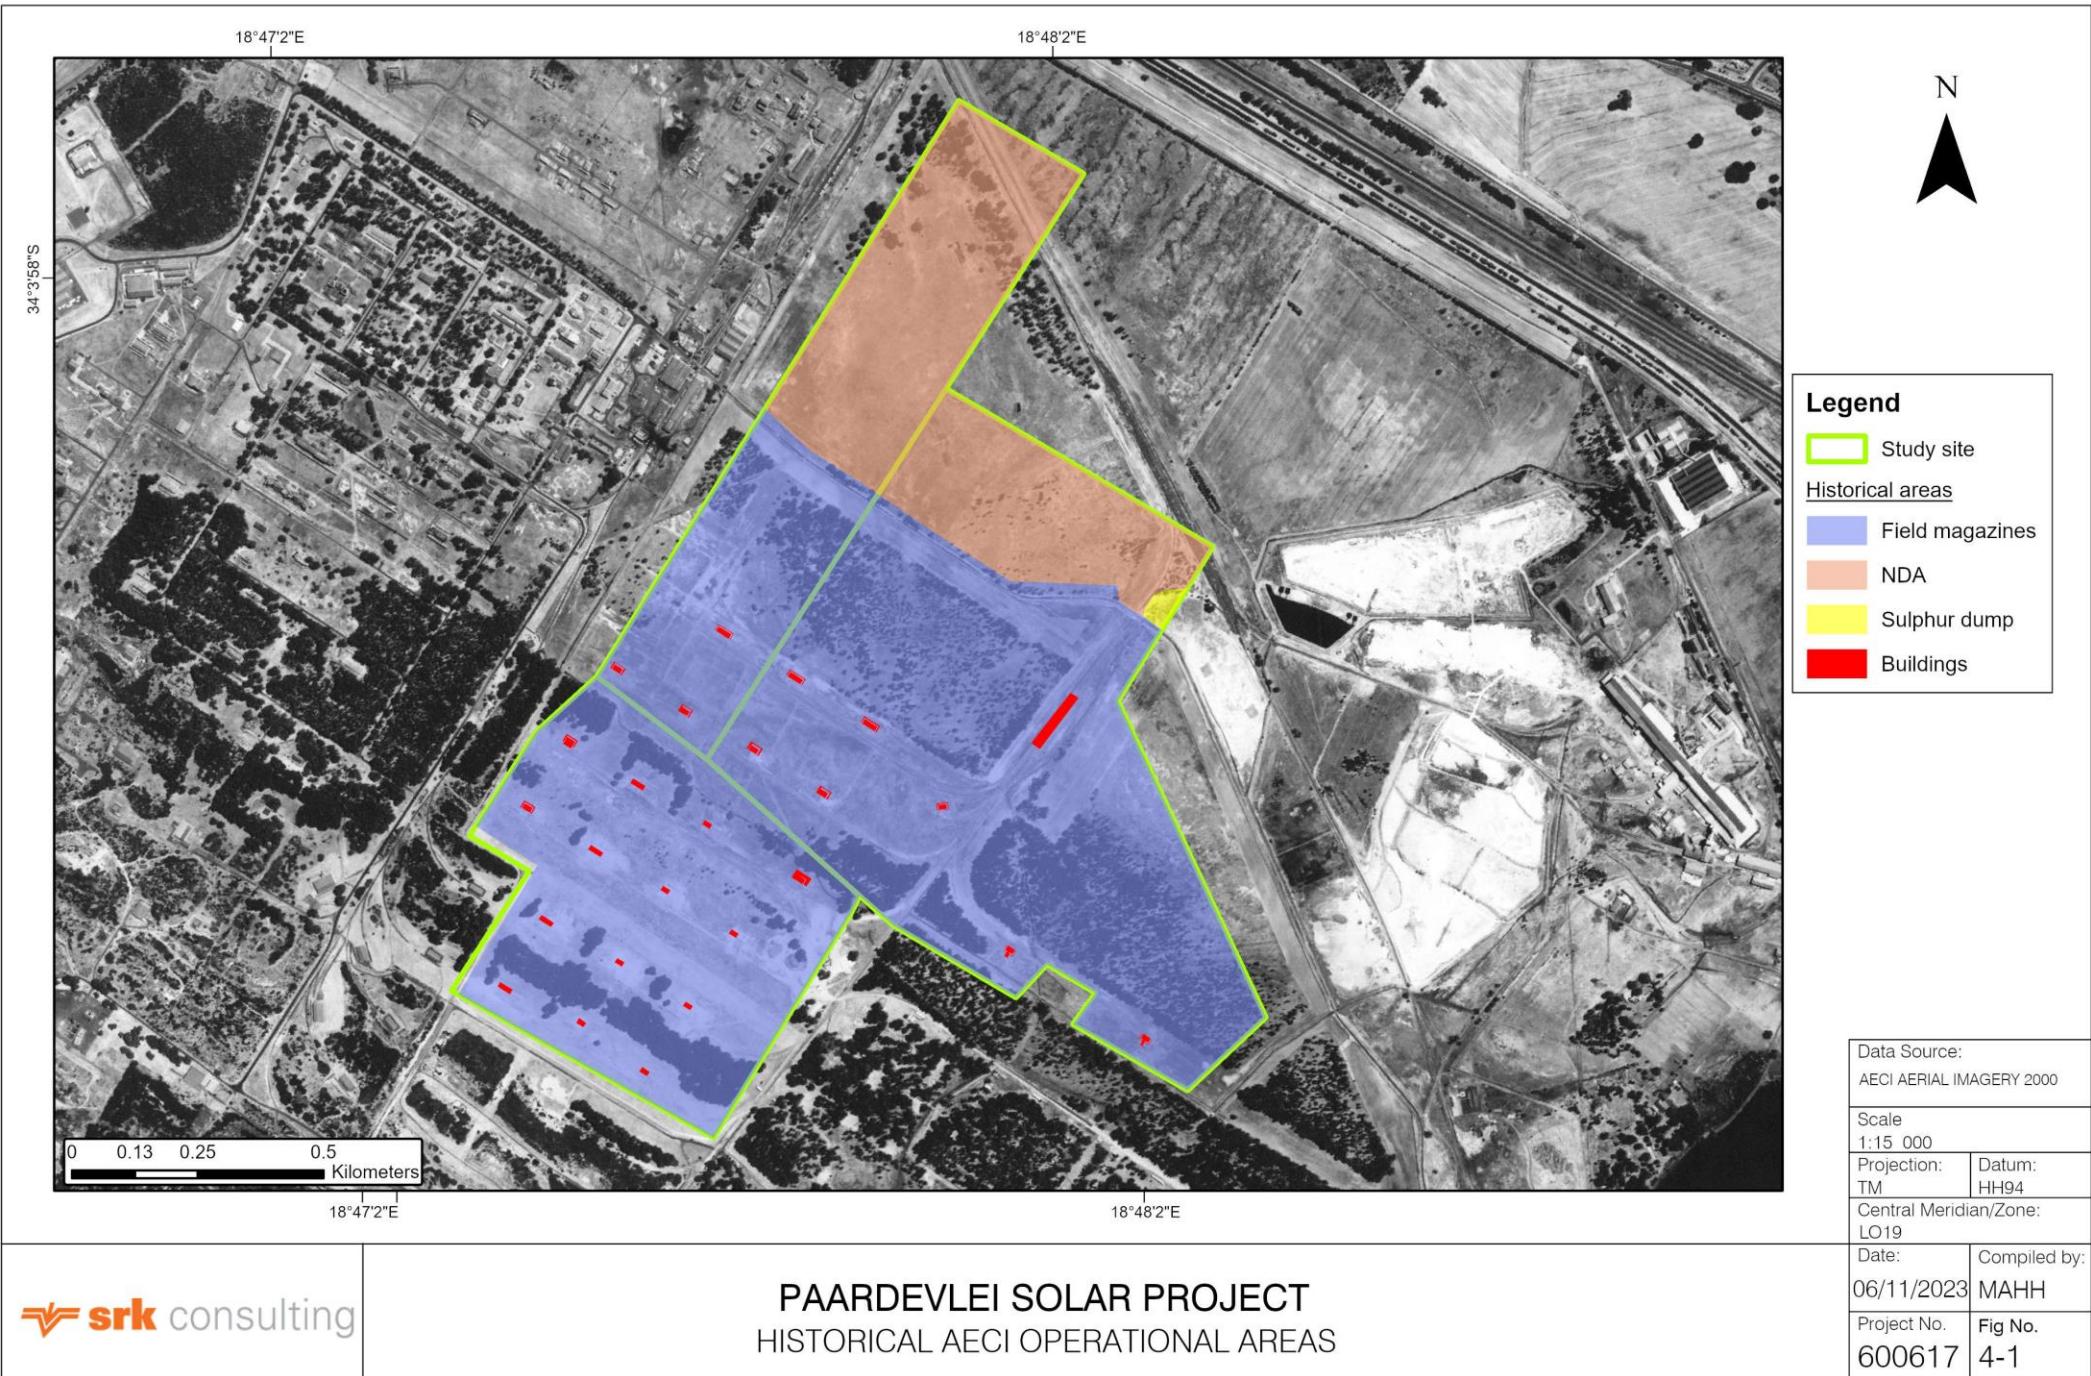
The initial characterisation of the greater AECL site entailed a historical review, site walkovers, installation of monitoring wells and soil and groundwater sampling. Following the initial assessments, the greater AECL Somerset West site was subdivided into smaller areas based on past production activities, which were then characterised individually. The former operational areas, which form part of the CoCT PV study area, are shown in Figure 4-1.

The Study Area comprises portions of the following former AECL operational areas:

- Field magazines.
- Sulfur Stockpile; and
- Northern Development Area (NDA).

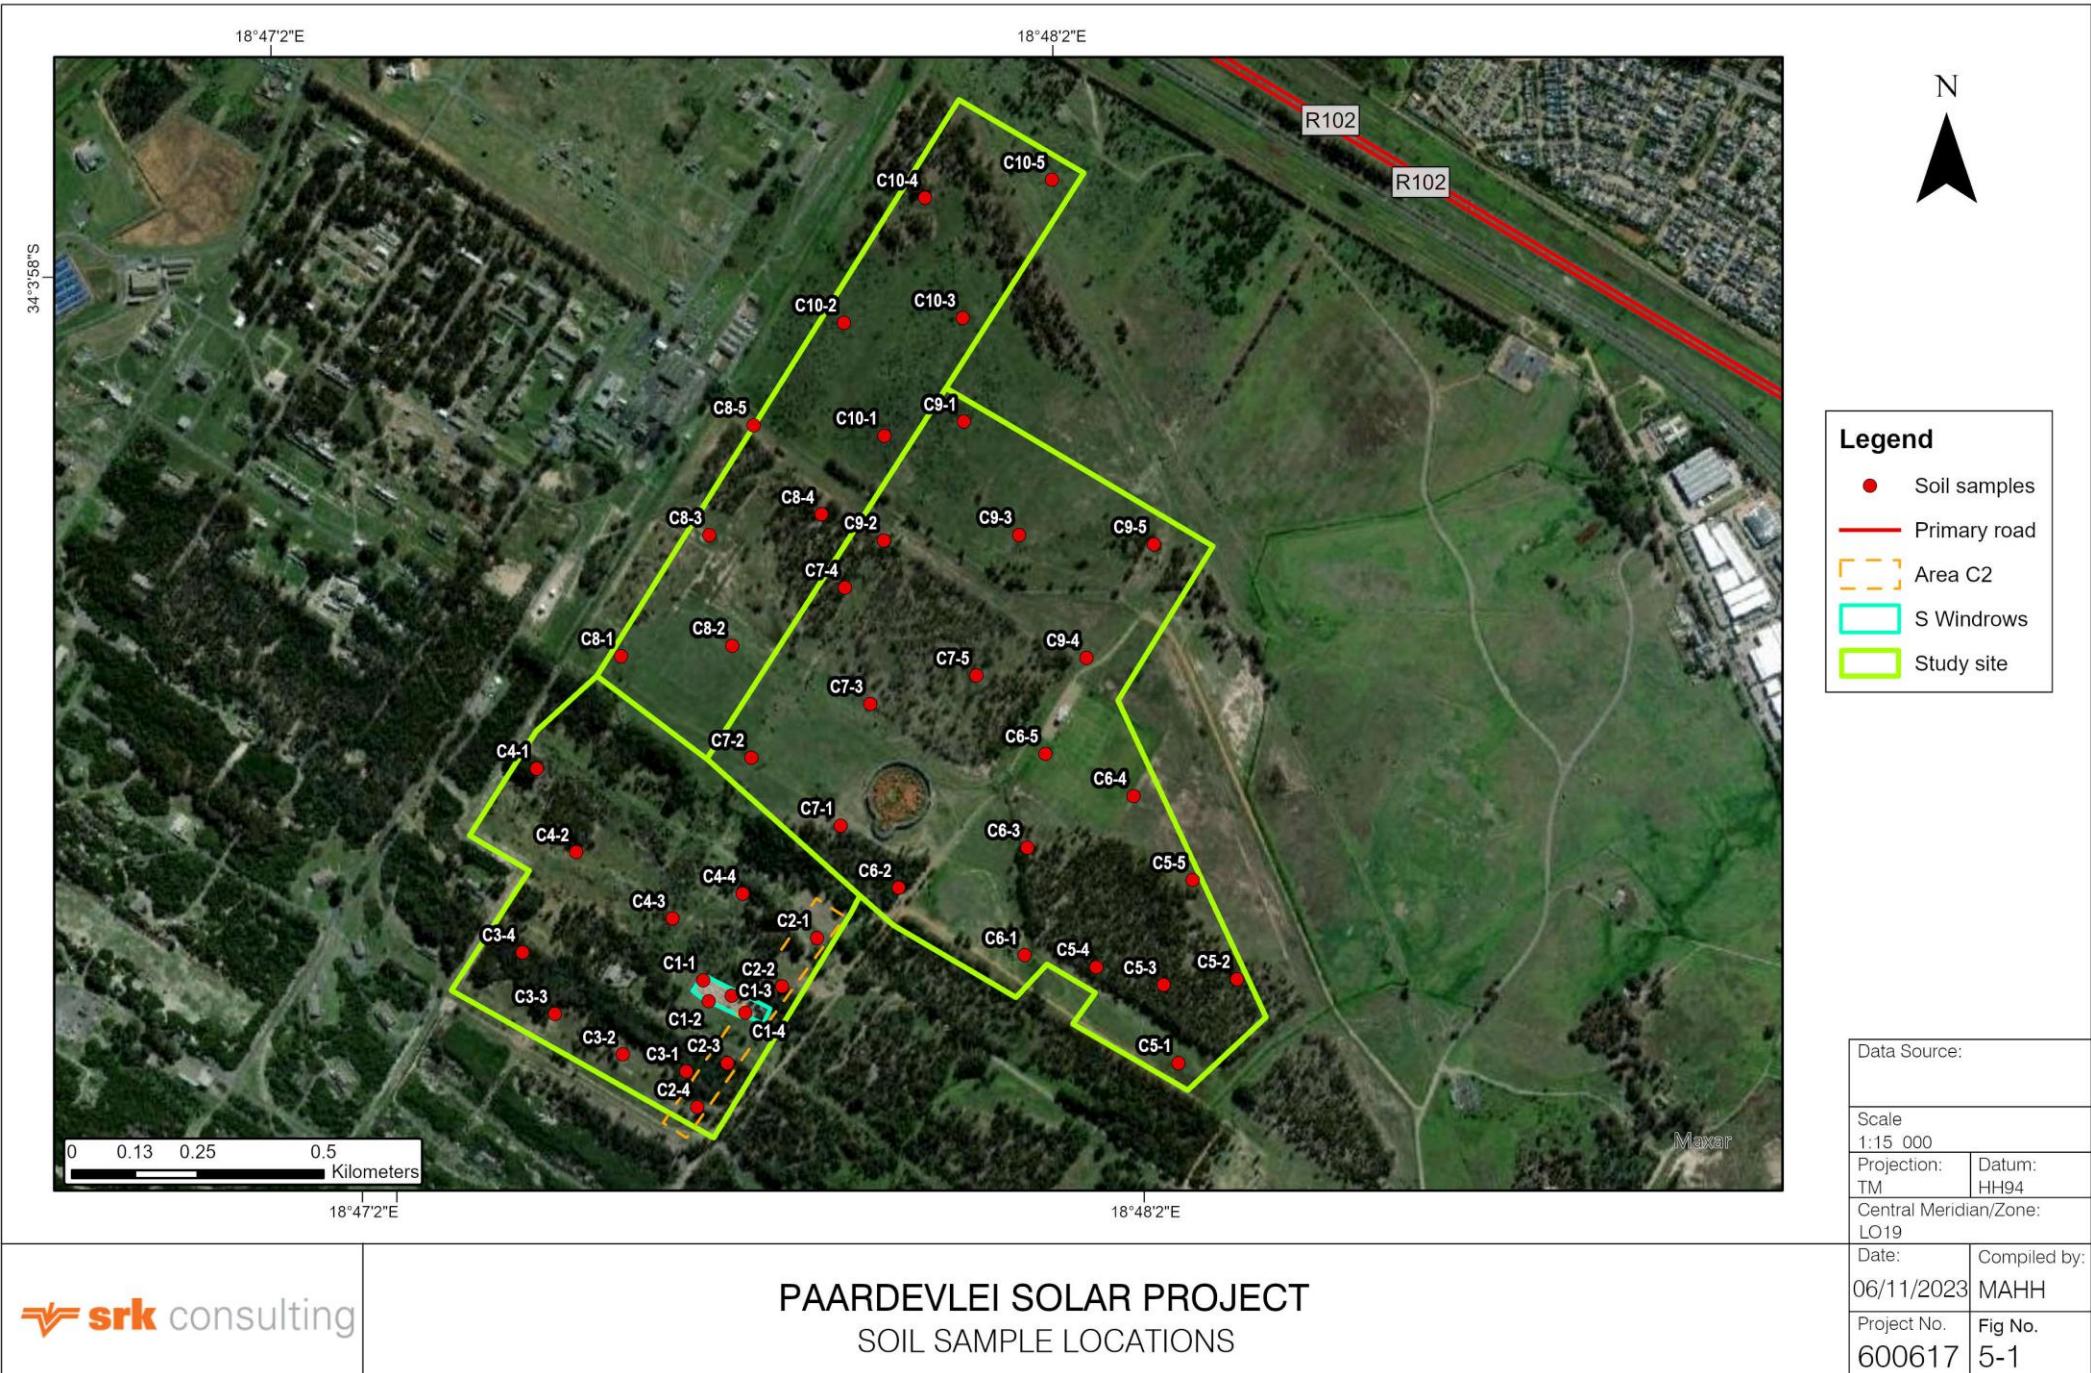
The soil profile varies across the site, generally comprising dry to slightly moist clayey sand overlying moist stiff sandy clay at depth. In the northern part of the study area, the underlying clay is typically dark grey and mottles comprising weathered Malmesbury shale. A coarse red quartzitic sand (Hillwash) is poorly developed in this area, while often being present.

Further south in the central portion of the study area, the underlying clay is light grey and occasionally contains hillwash sand confirming the reworked transported origin of the clays. In the southern portion of the study area, the depth of the underlying clay is often not observed within the upper 0.5 m and the auger refuses on shallow calcrete.

Several of the roads/railway lines, constructed in the study area to provide access to the field magazines, are built on coarse boiler ash from the former AECL power station. In the area between sample locations C2-1 and C2-2, a crusher plant was operated during the demolition of the former AECL plant, and several stockpiles of surplus soil and crushed material are present in this area.

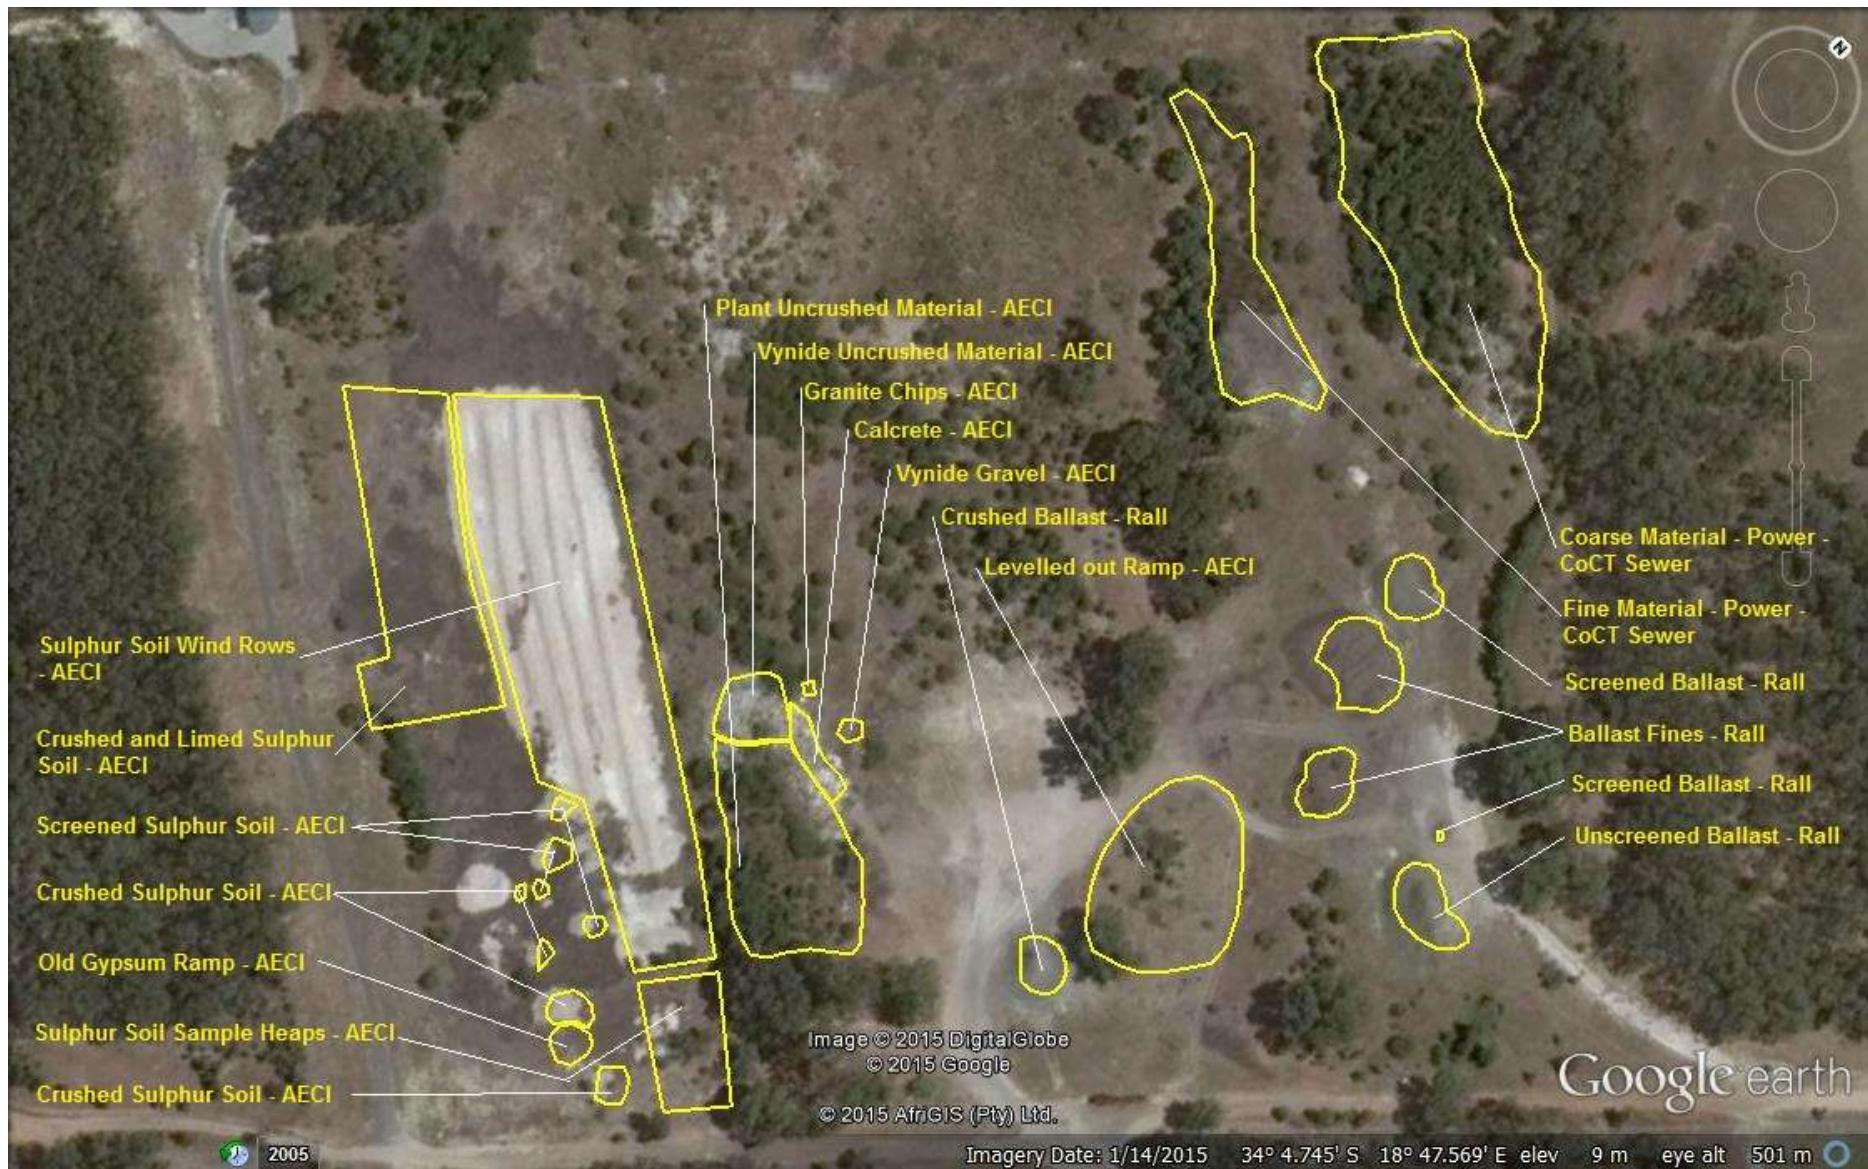
## Stockpiles on site in February 2015

<b>Stockpiles on Site on 25 February 2015</b>	
<b>Area</b>	<b>Est M3</b>
Coarse material - Power - CoCT Sewer	8800
Fine material - Power - CoCT Sewer	4000
Screened Ballast - Rall	530
Ballast Fines - Rall	1600
Unscreened Ballast - Rall	760
Levelled out ramp - AECI	980
Crushed Ballast - Rall	280
Old Gypsum Ramp - AECI	180
Plant Uncrushed Material - AECI	5000
Vynide Uncrushed Material - AECI	600
Calcrete - AECI	130
Granite chips - AECI	10
Vynide Gravel - AECI	60
Potch Sulphur Soil for Pilot Plant- AECI	30
Sulphur Soil from Stockpile for Trial - AECI	60
Sulphur Soil Stockpile Area	3900
