GEOHYDROLOGICAL ASSESSMENT FOR THE PAARDEVLEI SOLAR PV SITE CLOSE TO SOMERSET WEST, WESTERN CAPE

OCTOBER 2024

Ref: 006049V2

Geohydrological assessment for the proposed Paardevlei Solar PV facility

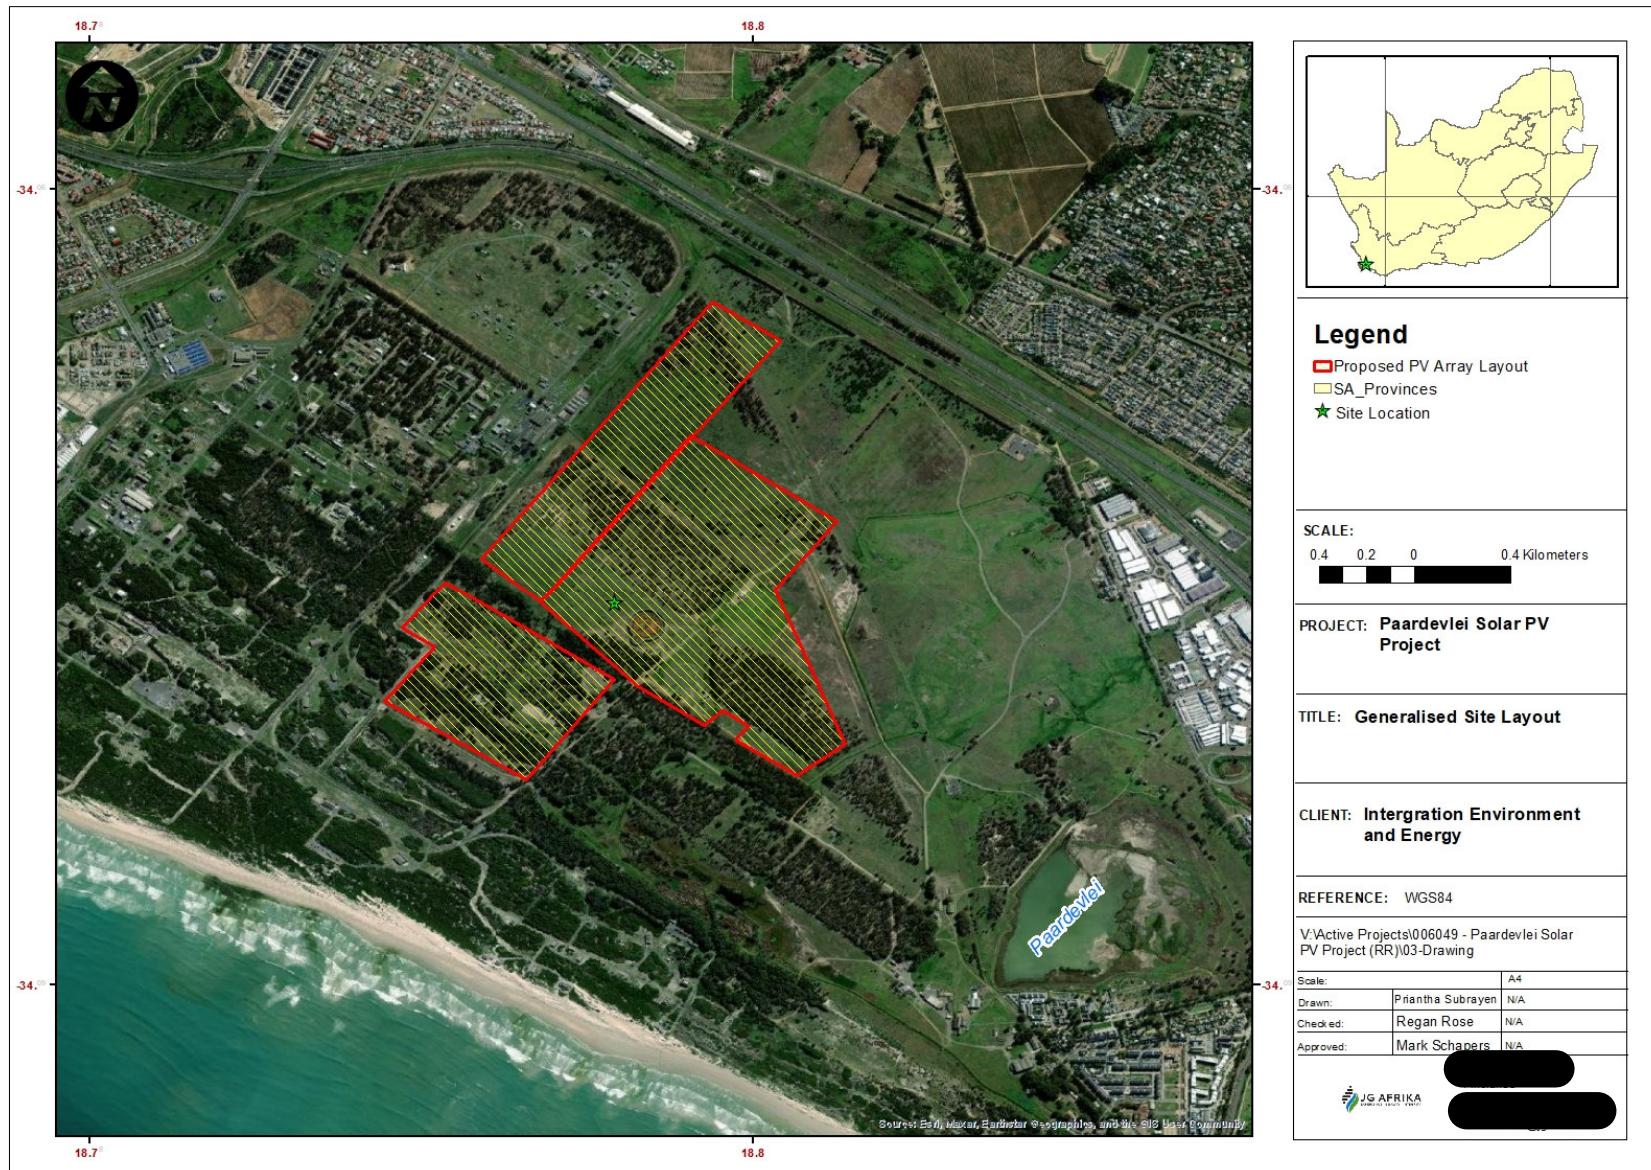
Figure 2: Generalised Site Layout

The site is at present vacant with several active and non-active monitoring boreholes present throughout. The activities associated with the project include site establishment of contractors and set-up of site camps and operation and maintenance buildings, the construction of temporary access roads and other construction related activities including site clearing, excavation, stock piling of materials and civil engineering works. Domestic waste generated during the course of the construction phase would be collected and stored in suitable receptacles onsite for collection and disposal at an appropriately licensed municipal waste site or acceptable disposal facility. Water would be required for dust suppression (on stockpiles and the access roads) and ancillary activities associated with the construction operations (washing of vehicles and equipment) and general use. A generalised site layout is provided in Figure 2.

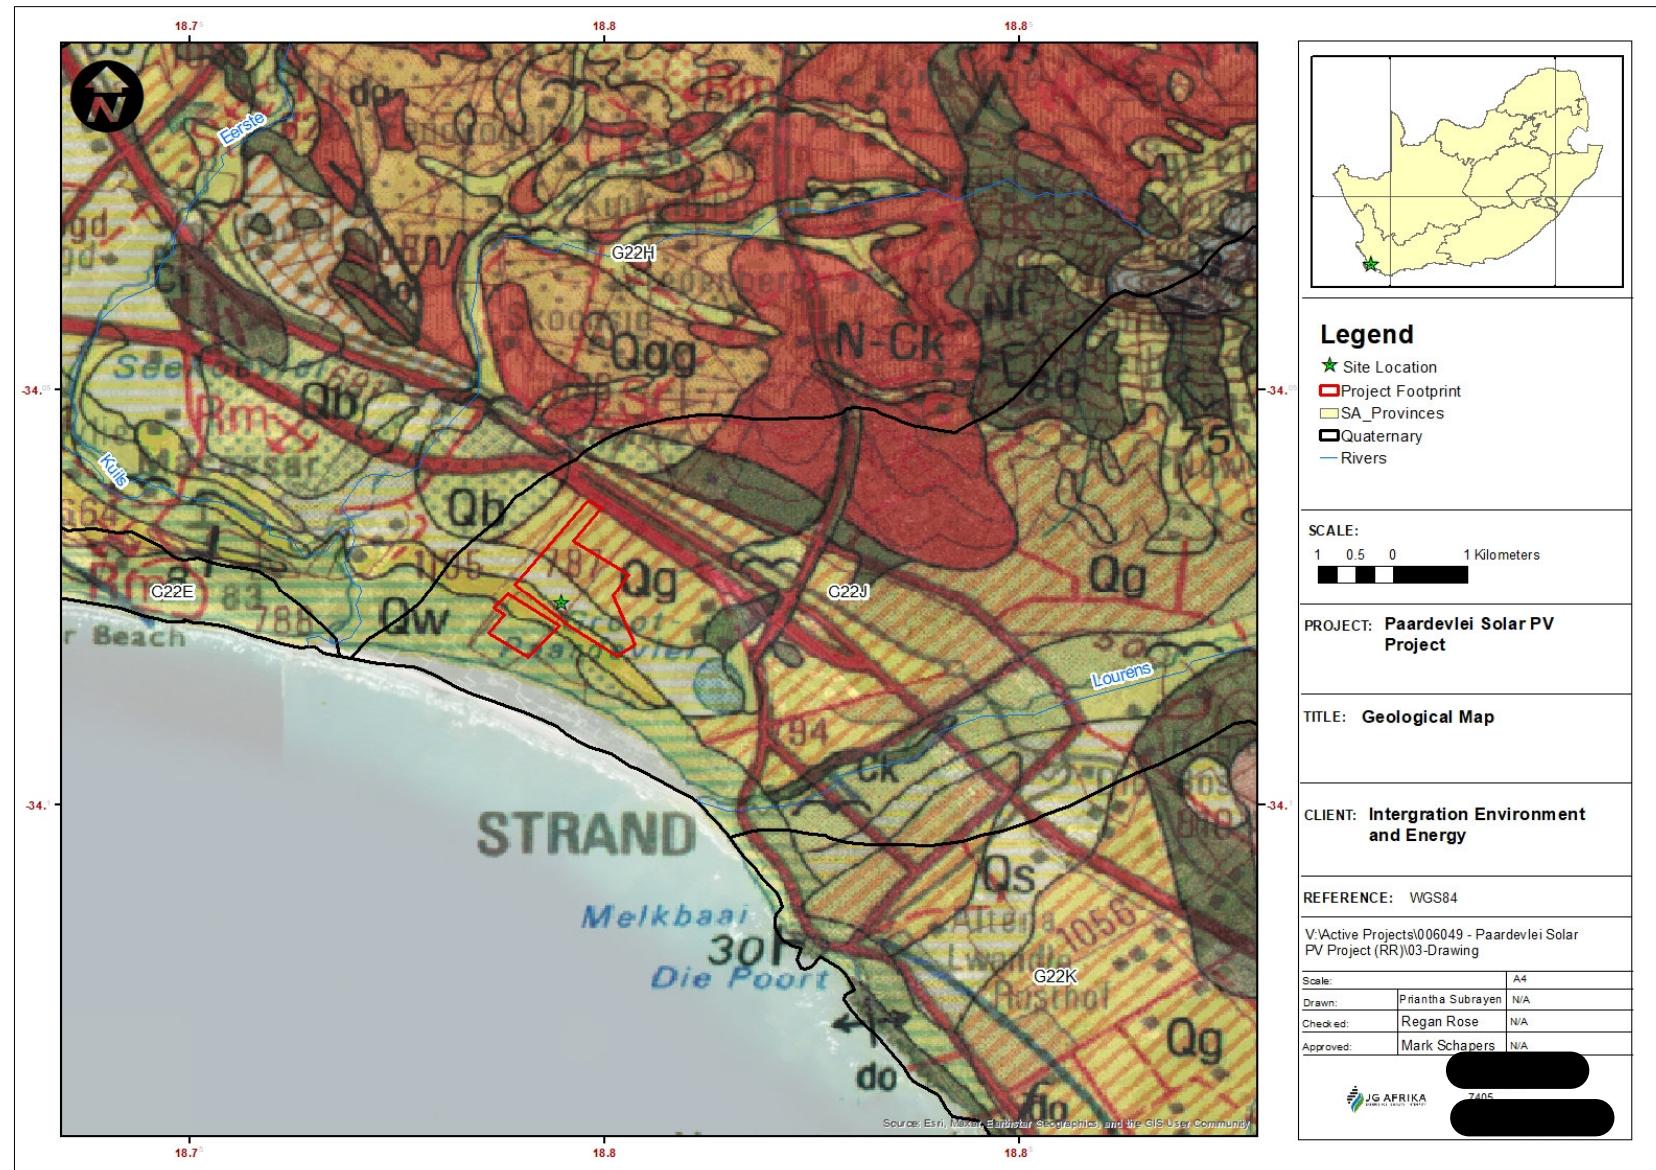
Figure 3: Regional Geology

The regional geology of the area comprises greywacke, phyllite, quartzitic sandstone and interbedded lava of the Tygerberg Formation (Nt). Plutons of the Cape Granite Suite (N-Ck) have intruded the Tygerberg Formation to the north of the study area. These rock units mainly comprise porphyritic, leucocratic, hybridic or tourmaline bearing biotic granite. Additionally, localised Post Karoo dolerite intrusions (do) are present to the north west of the site. These intrusions are however mostly confined to the Tygerberg Formation shale. The unconsolidated to semi-consolidated, heterogenous Quaternary deposits of the Sandveld Group including the basal Springfontyn Formation (Qs) and younger Langebaan (Ql) and Witzand Formations (Qw), respectively, overlie the Tygerberg Formation and Cape Granite Suite in the area. Occurring in the immediate vicinity of the Paardenvlei Solar PV development area, the Langebaan Formation is composed of limestone and calcrete and partially cross bedded parabolic dune sands, together with alluvium (along riverbeds) and underlies the south western boundary. The central and north eastern margins are underlain by the Springfontein Formation with gravelly clay and loam soils (Qg) characterising areas to the north and north east.

In order of priority, faults, dykes, lineaments and geological contacts typically provide zones of heightened groundwater potential. No faults or lineaments were identified within a 5km radius of the site however, mapped dolerite intrusions were noted to the north west on the extremity of the 5km buffer.

A summary of the regional geology is presented Table 1 and shown in Figure 3.

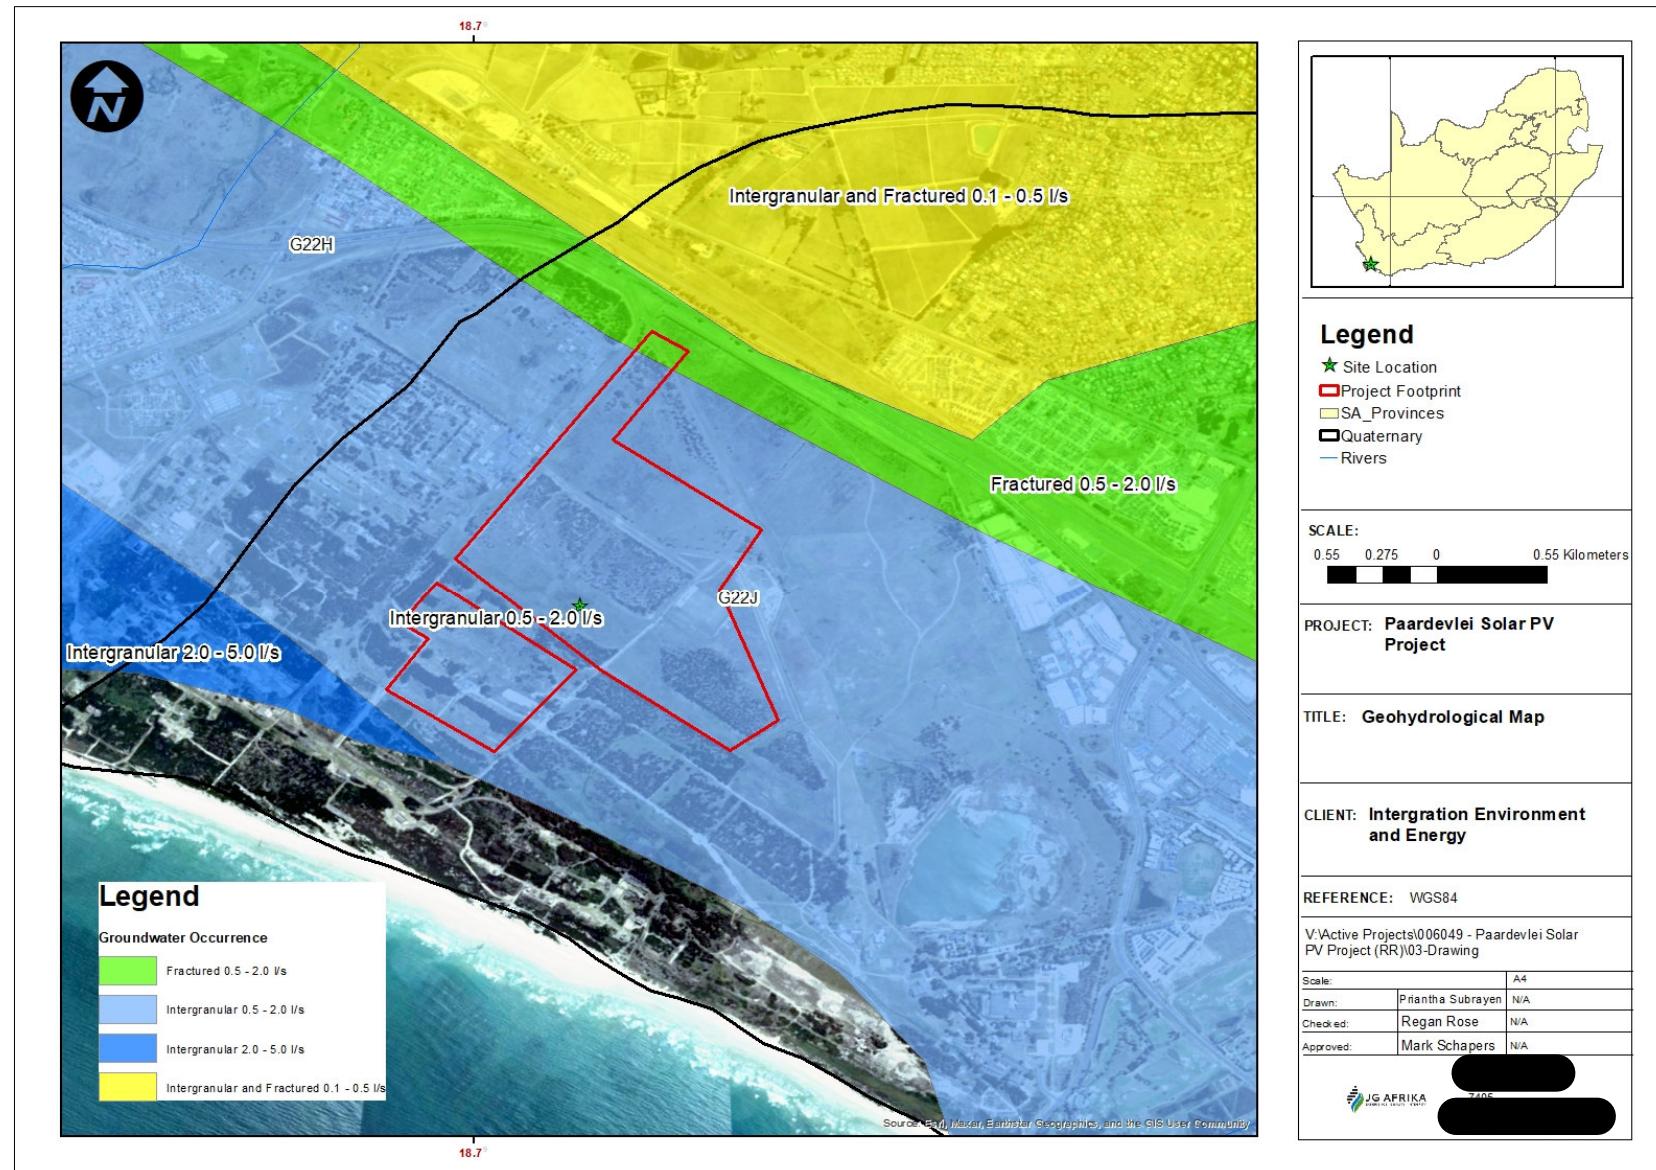
Figure 4: Regional Geohydrology

The regional geohydrology of the study area comprises of a two layered aquifer system. A primary intergranular aquifer which is characterised by undifferentiated coastal deposits and a secondary, fractured aquifer belonging to the deeper seated Tygerberg Formation. Median borehole yields in the range of 0.5l/s to 2.0l/s can be expected for both the primary and secondary aquifers which are considered to be moderate to high yielding aquifers in terms of the South African Aquifer Classification System. Electrical Conductivity as indicated in the 1: 5000 Hydrogeological Map of Cape Town indicates ranges from 70 mS/m to 300 mS/m. The regional geohydrology of the site is presented in Figure 4.

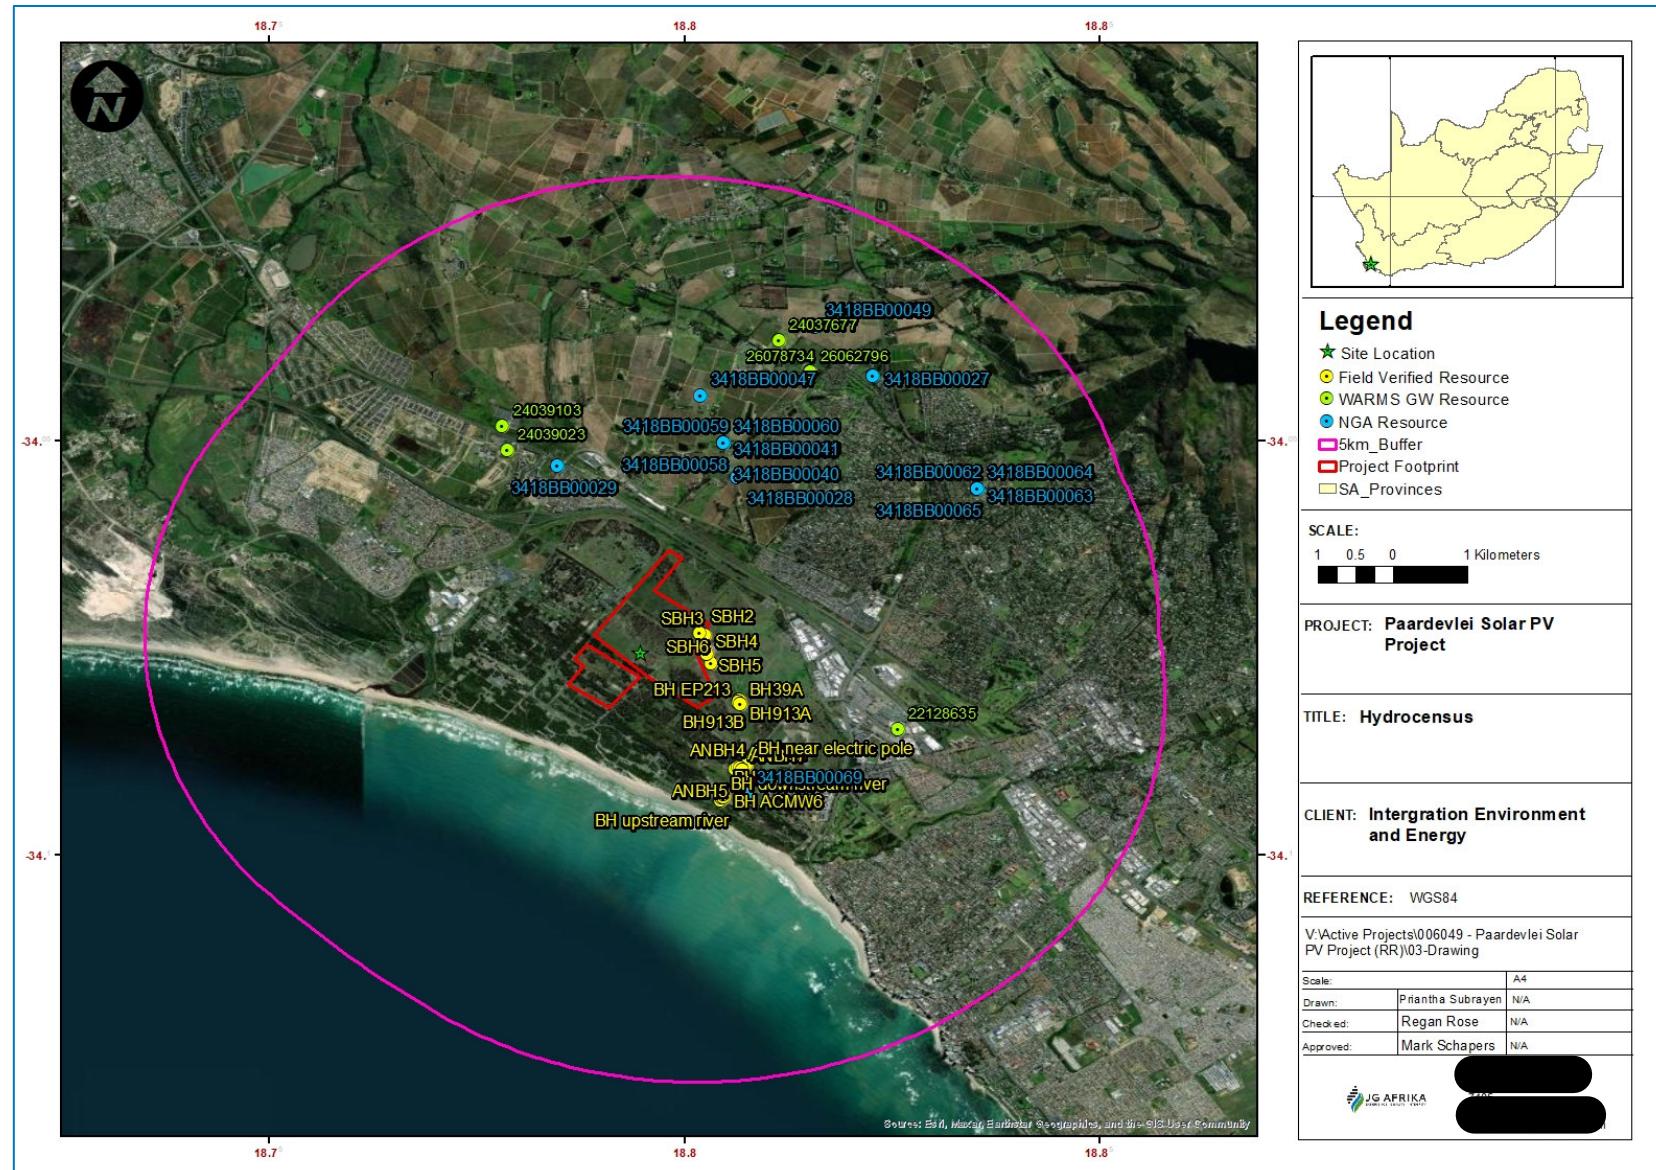
Figure 5: Hydrocensus

The National Groundwater Archive (NGA) and Water Use Authorization and Registration Management System (WARMS) of the DWS were interrogated to establish the existence of any groundwater resources and groundwater use in proximity to the site. The NGA reported twenty-two (22 No.) resources within 5 km of the site, while the WARMS reported seven (7 No.) resources. The resources are summarised in Table 2. The locations of these resources as presented in the DWS databases are shown in Figure 5. Field verified resources are included in Table 2, with seven (7 No.) boreholes being identified within 300m of the Paardevlei Solar PV site. These boreholes are mainly monitoring boreholes. The field verified groundwater resources are provided in Annexure B.

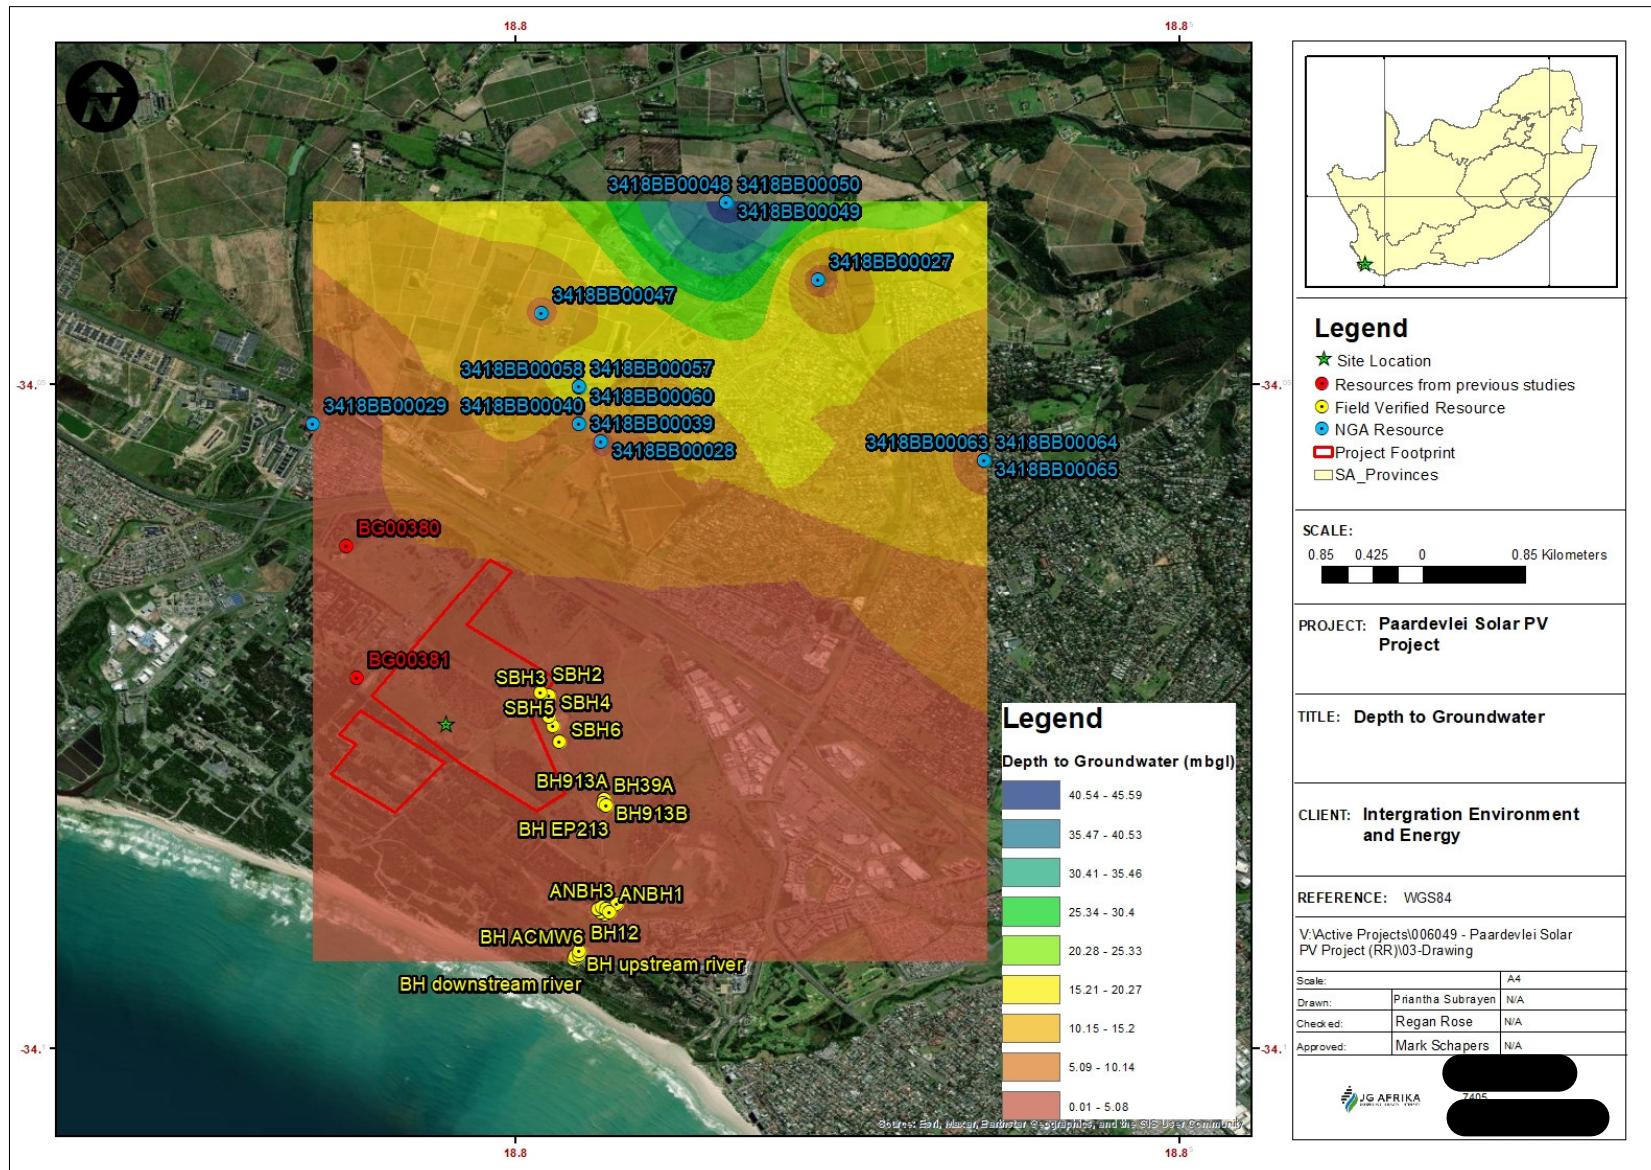
Figure 6: Depth to Groundwater

The measured depth to groundwater was recorded to range between 0.0mbgl to 8.2mbgl at boreholes near the site (Figure 6). The inferred groundwater flow direction is from northeast to southwest towards the Atlantic Ocean and is presented in Figure 7.

The inferred groundwater flow direction in the project footprint is from north east to south west across the area as indicated in Figure 6. None of the groundwater resources that were identified during the hydrocensus are therefore considered to be potential receptors.

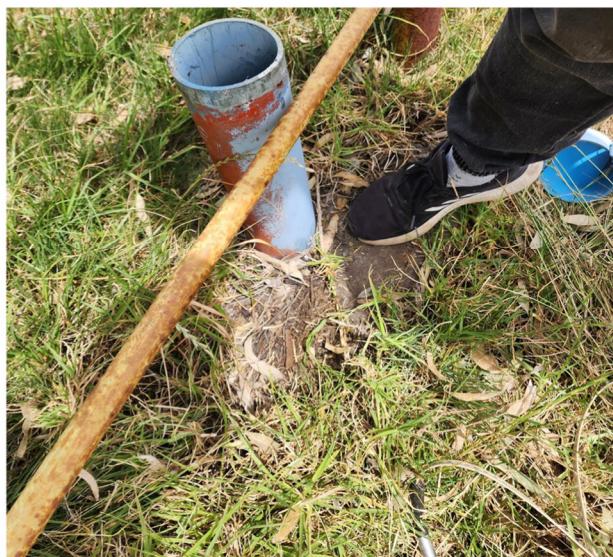
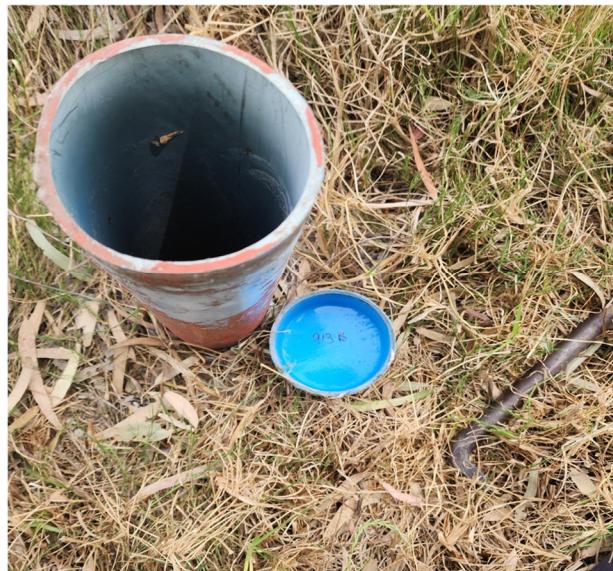
GROUNDWATER RESOURCES LOCATED AND ASSESSED IN THE HYDROCENSUS	
Resource ID	BH913A
Latitude	-34.081313
Longitude	18.806769
Resource Type	Monitoring Borehole
NGA/GRIP No	-
Sample No.	-
Current Use	Not in use
Depth to GW (m)	1.05
Final Depth (mbgl)	16.5
BH Diameter (mm)	140
Casing Diameter (mm)	140
Casing Revealed (cm)	0
Comments	Water was pumped out at 0.25 l/s for 20 minutes. All the water in the borehole column was pumped out after 20 minutes which means the recovery rate is very low.
Resource ID	BH913B
Latitude	-34.081328
Longitude	18.806778
Resource Type	Monitoring Borehole
NGA/GRIP No	-
Sample No.	-
Current Use	Not In use
Depth to GW (mbgl)	1.17
Final Depth (mbgl)	4.44
BH Diameter (mm)	140
Casing Diameter (mm)	140
Casing Revealed (cm)	0
Comments	Water was pumped out at 0.25 l/s for 10 minutes. All the water in the borehole column was pumped out after 10 minutes which means the recovery rate is very low.

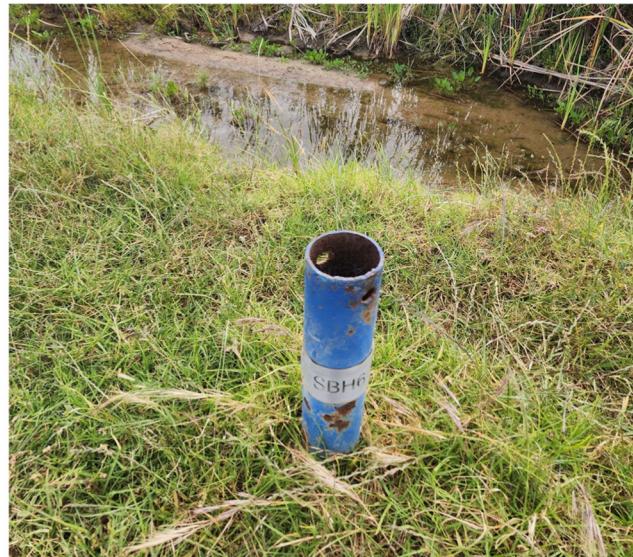
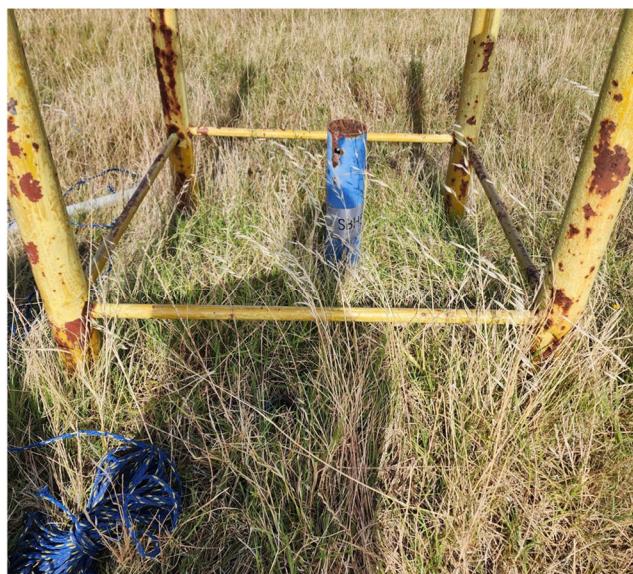
GROUNDWATER RESOURCES LOCATED AND ASSESSED IN THE HYDROCENSUS	
Resource ID	SBH6
Latitude	-34.076954
Longitude	18.803354
Resource Type	Monitoring Borehole
NGA/GRIP No	-
Sample No.	-
Current Use	Not In use
Depth to GW (mbgl)	1.59
Final Depth (mbgl)	3.8
BH Diameter (mm)	130
Casing Diameter (mm)	130
Casing Revealed (cm)	0
Comments	The borehole was pumped for 5 minutes and dried up using a low flow sampling pump. The yield is not reported. There is a surface water body opposite the borehole
Resource ID	SBH5
Latitude	-34.075810
Longitude	18.802893
Resource Type	Monitoring Borehole
NGA/GRIP No	-
Sample No.	-
Current Use	Not In use
Depth to GW (mbgl)	1.64
Final Depth (mbgl)	2.29
BH Diameter (mm)	130
Casing Diameter (mm)	130
Casing Revealed (cm)	-
Comments	The yield is not reported. Sample was taken with bailer where water was purged 3 times the volume water of the borehole.

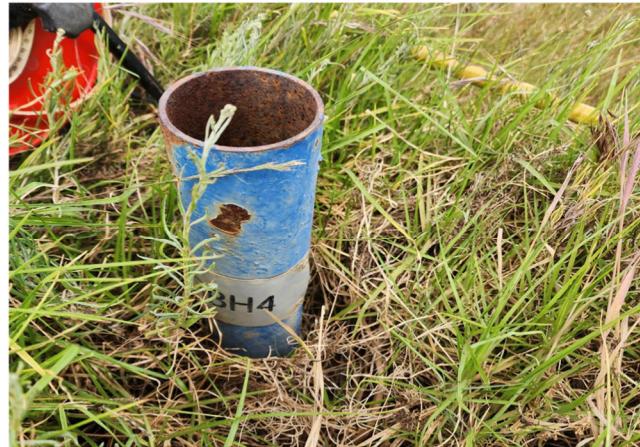
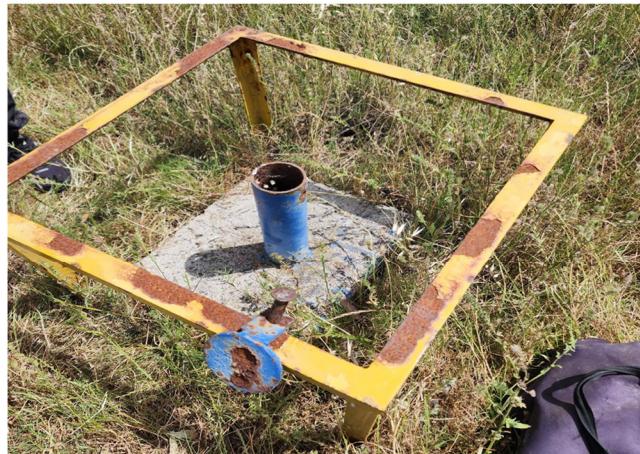
GROUNDWATER RESOURCES LOCATED AND ASSESSED IN THE HYDROCENSUS	
Resource ID	SBH4
Latitude	-34.075099
Longitude	18.802591
Resource Type	Monitoring Borehole
NGA/GRIP No	-
Sample No.	-
Current Use	Not In use
Depth to GW (mbgl)	1.32
Final Depth (mbgl)	2.78
BH Diameter (mm)	130
Casing Diameter (mm)	130
Casing Revealed (cm)	0
Comments	The yield is not reported. Sample was taken with bailer where water was purged 3 times the volume water of the borehole.
Resource ID	SBH3
Latitude	-34.073532
Longitude	18.802622
Resource Type	Monitoring Borehole
NGA/GRIP No	-
Sample No.	-
Current Use	Not In use
Depth to GW (mbgl)	1.84
Final Depth (mbgl)	3.14
BH Diameter (mm)	130
Casing Diameter (mm)	130
Casing Revealed (cm)	-
Comments	The yield is not reported. Sample was taken with bailer where water was purged 3 times the volume water of the borehole.

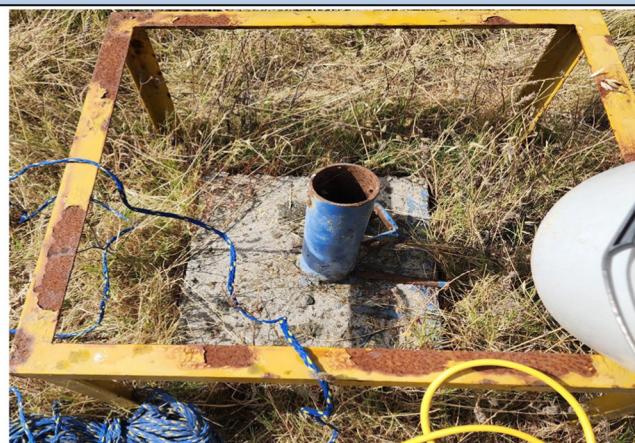
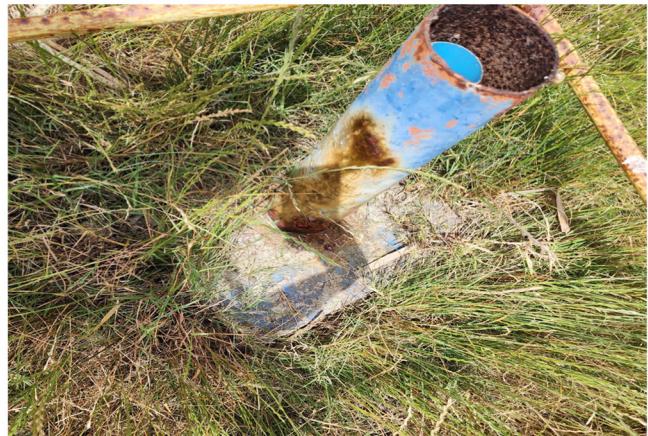
GROUNDWATER RESOURCES LOCATED AND ASSESSED IN THE HYDROCENSUS	
Resource ID	SBH2
Latitude	-34.073312
Longitude	18.801986
Resource Type	Monitoring Borehole
NGA/GRIP No	-
Sample No.	-
Current Use	Not In use
Depth to GW (mbgl)	1.71
Final Depth (mbgl)	2.75
BH Diameter (mm)	130
Casing Diameter (mm)	130
Casing Revealed (cm)	0
Comments	The yield is not reported. Sample was taken with bailer where water was purged 3 times the volume of water in the borehole.
Resource ID	BH39A
Latitude	-34.081642
Longitude	18.806672
Resource Type	Monitoring Borehole
NGA/GRIP No	-
Sample No.	-
Current Use	Not In use
Depth to GW (mbgl)	1.03
Final Depth (mbgl)	35.65
BH Diameter (mm)	130
Casing Diameter (mm)	120
Casing Revealed (cm)	-
Comments	The yield is not reported. Sample was taken with bailer where water was purged 3 times the volume of water in the borehole.

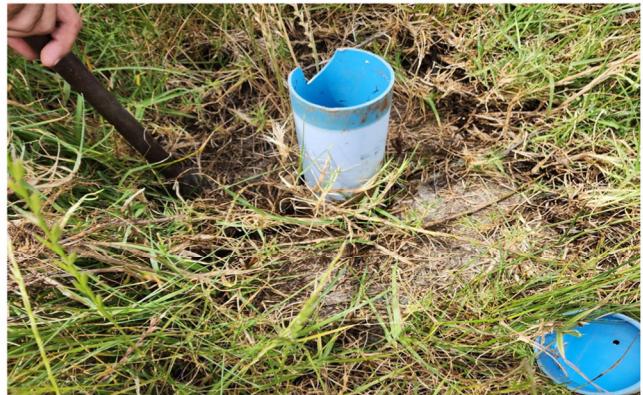
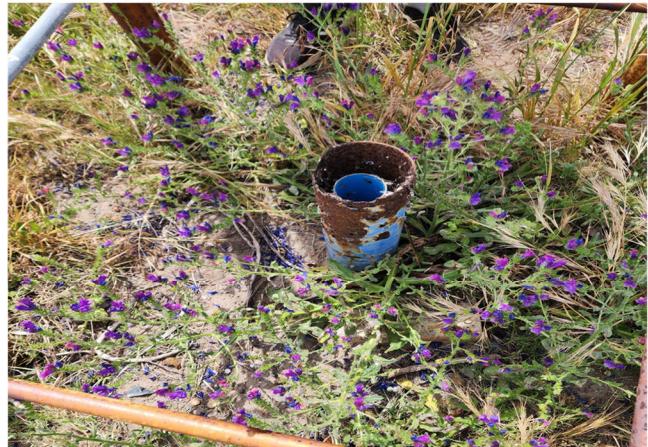
GROUNDWATER RESOURCES LOCATED AND ASSESSED IN THE HYDROCENSUS	
Resource ID	BH EP213
Latitude	-34.081785
Longitude	18.806881
Resource Type	Monitoring Borehole
NGA/GRIP No	-
Sample No.	-
Current Use	Not in use
Depth to GW (mbgl)	1.48
Final Depth (mbgl)	5.54
BH Diameter (mm)	120
Casing Diameter (mm)	120
Casing Revealed (cm)	0
Comments	Used bailer and purged 20 L of water. Sustainable yield unknown.
Resource ID	BH near electric pole
Latitude	-34.089158
Longitude	18.807667
Resource Type	Monitoring Borehole
NGA/GRIP No	-
Sample No.	-
Current Use	Not in use
Depth to GW (mbgl)	1.36
Final Depth (mbgl)	6.21
BH Diameter (mm)	130
Casing Diameter (mm)	170
Casing Revealed (cm)	-
Comments	Water was pumped out at 0.25 l/s for 10 minutes. All the water in the borehole column was pumped out after 10 minutes which means the recovery rate is very low.

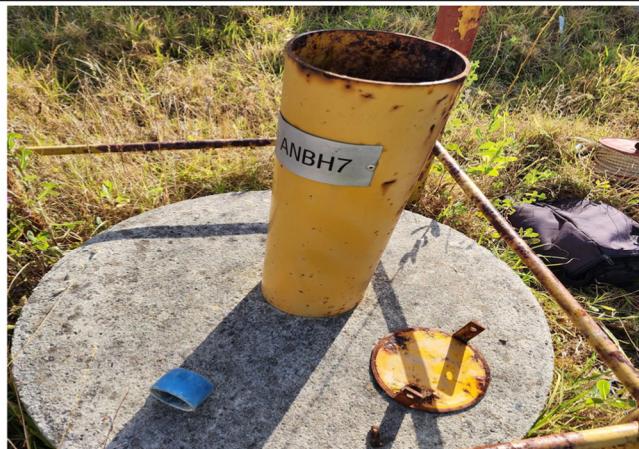
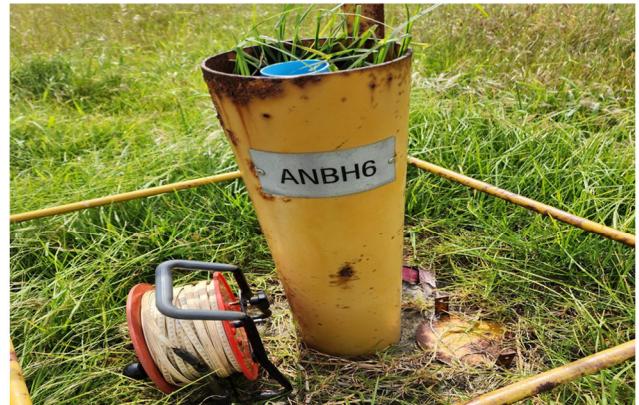
GROUNDWATER RESOURCES LOCATED AND ASSESSED IN THE HYDROCENSUS	
Resource ID	ANBH7
Latitude	-34.089954
Longitude	18.806811
Resource Type	Monitoring Borehole
NGA/GRIP No	-
Sample No.	-
Current Use	In use
Depth to GW (mbgl)	2.04
Final Depth (mbgl)	4.88
BH Diameter (mm)	165
Casing Diameter (mm)	170
Casing Revealed (cm)	0
Comments	Borehole drilled at 6.21 m. The yield of the borehole is unknown.
Resource ID	ANBH6
Latitude	-34.089789
Longitude	18.806478
Resource Type	Monitoring Borehole
NGA/GRIP No	-
Sample No.	-
Current Use	In use
Depth to GW (mbgl)	2.07
Final Depth (mbgl)	5.52
BH Diameter (mm)	165
Casing Diameter (mm)	170
Casing Revealed (cm)	-
Comments	Grass growing around and within the borehole casing. Sustainable yield unknown.

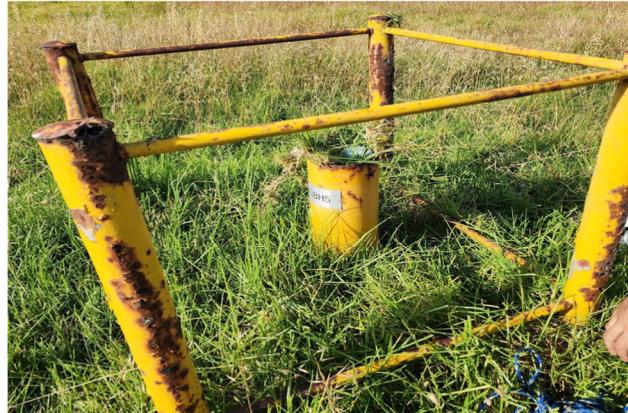
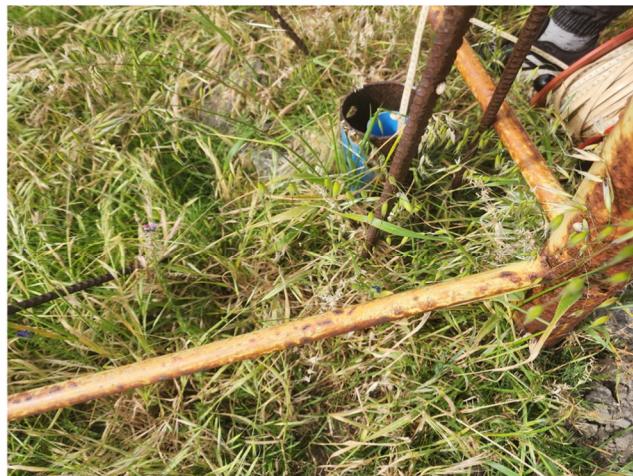
GROUNDWATER RESOURCES LOCATED AND ASSESSED IN THE HYDROCENSUS	
Resource ID	ANBH5
Latitude	-34.089575
Longitude	18.806270
Resource Type	Monitoring Borehole
NGA/GRIP No	-
Sample No.	-
Current Use	Not In use
Depth to GW (mbgl)	1.48
Final Depth (mbgl)	6.21
BH Diameter (mm)	165
Casing Diameter (mm)	170
Casing Revealed (cm)	0
Comments	Grass growing around and within the borehole casing. Sustainable yield unknown. Borehole is poorly maintained and managed.
Resource ID	ANBH4
Latitude	-34.089394
Longitude	18.806608
Resource Type	Monitoring Borehole
NGA/GRIP No	-
Sample No.	-
Current Use	Not In use
Depth to GW (mbgl)	1.84
Final Depth (mbgl)	6.76
BH Diameter (mm)	165
Casing Diameter (mm)	170
Casing Revealed (cm)	-
Comments	Grass growing around and within the borehole casing. Sustainable yield unknown. Borehole is poorly maintained and managed.

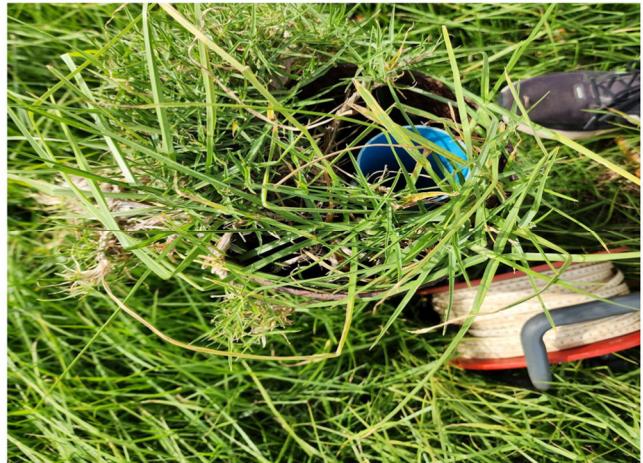
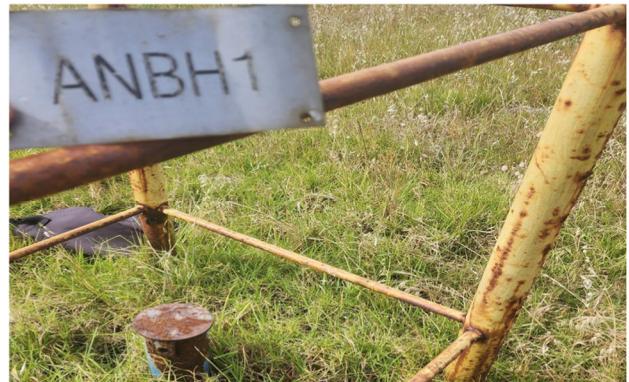
GROUNDWATER RESOURCES LOCATED AND ASSESSED IN THE HYDROCENSUS	
Resource ID	ANBH3
Latitude	-34.089544
Longitude	18.806908
Resource Type	Monitoring Borehole
NGA/GRIP No	-
Sample No.	-
Current Use	Not in use
Depth to GW (mbgl)	1.48
Final Depth (mbgl)	6.21
BH Diameter (mm)	165
Casing Diameter (mm)	170
Casing Revealed (cm)	0
Comments	Grass growing around and within the borehole casing. Sustainable yield unknown. Borehole is poorly maintained and managed.
Resource ID	ANBH1
Latitude	-34.089758
Longitude	18.807111
Resource Type	Monitoring Borehole
NGA/GRIP No	-
Sample No.	-
Current Use	Not in use
Depth to GW (mbgl)	1.36
Final Depth (mbgl)	7.62
BH Diameter (mm)	165
Casing Diameter (mm)	170
Casing Revealed (cm)	-
Comments	Dried up

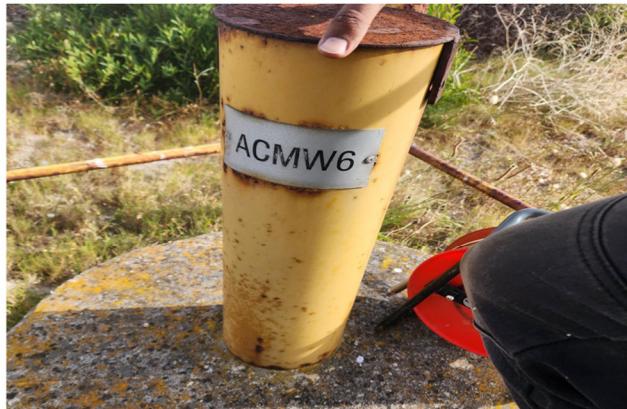
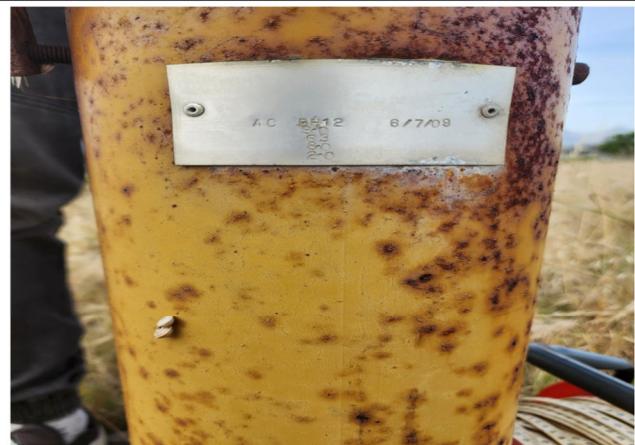
ROUNDWATER RESOURCES LOCATED AND ASSESSED IN THE HYDROCENSUS	
Resource ID	BH ACMW6
Latitude	-34.093003
Longitude	18.804875
Resource Type	Monitoring Borehole
NGA/GRIP No	-
Sample No.	-
Current Use	In use
Depth to GW (mbgl)	8.2
Final Depth (mbgl)	11.7
BH Diameter (mm)	165
Casing Diameter (mm)	170
Casing Revealed (cm)	0
Comments	Sustainable yield unknown
Resource ID	BH12
Latitude	-34.092675
Longitude	18.804847
Resource Type	Borehole
NGA/GRIP No	-
Sample No.	-
Current Use	Not In use
Depth to GW (mbgl)	7.85
Final Depth (mbgl)	9.3
BH Diameter (mm)	165
Casing Diameter (mm)	170
Casing Revealed (cm)	-
Comments	Borehole was reported to be drilled to 38m, but now only measures 33.67mbgl. The yield is reported as 6.67l/s for 24hrs/day.

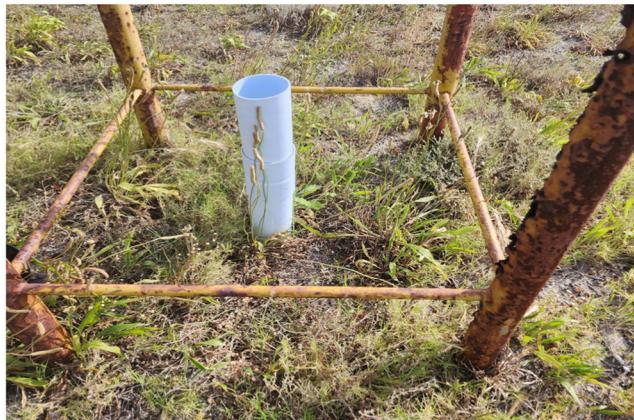
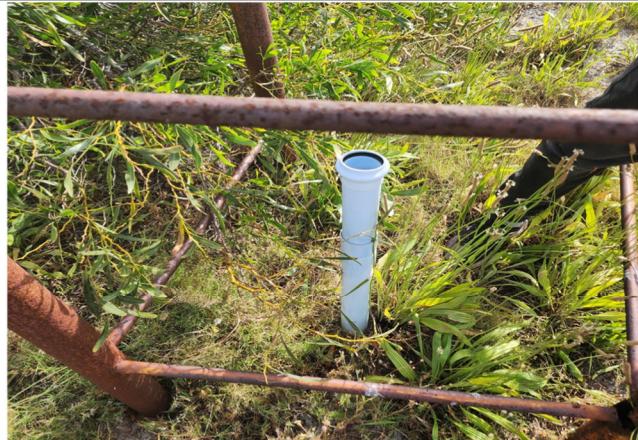
GROUNDWATER RESOURCES LOCATED AND ASSESSED IN THE HYDROCENSUS	
Resource ID	BH downstream river
Latitude	-34.093085
Longitude	18.804587
Resource Type	Borehole
NGA/GRIP No	-
Sample No.	-
Current Use	Not In use
Depth to GW (mbgl)	0 (dried up/collapsed)
Final Depth (mbgl)	3.11
BH Diameter (mm)	130
Casing Diameter (mm)	130
Casing Revealed (cm)	0
Comments	Borehole was reported to be drilled to 35m, but is now blocked and filled with debris. The yield is not reported
Resource ID	BH upstream river
Latitude	-34.093369
Longitude	18.804444
Resource Type	Borehole
NGA/GRIP No	-
Sample No.	-
Current Use	Not In use
Depth to GW (mbgl)	0 (dried up/collapsed)
Final Depth (mbgl)	5.37
BH Diameter (mm)	115
Casing Diameter (mm)	115
Casing Revealed (cm)	-
Comments	Borehole was reported to be drilled to 38m, but now only measures 33.67mbgl. The yield is reported as 6.67l/s for 24hrs/day.

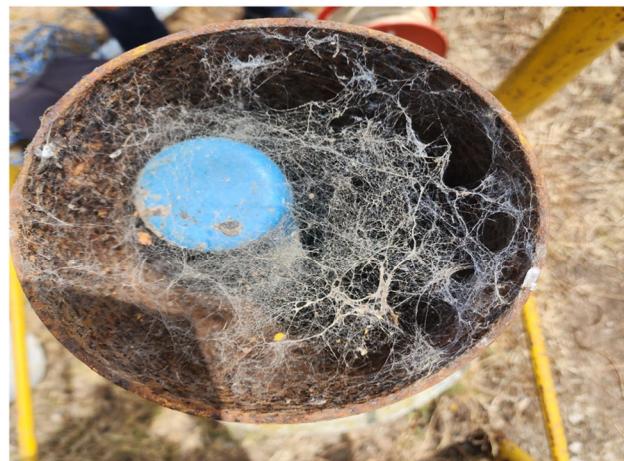
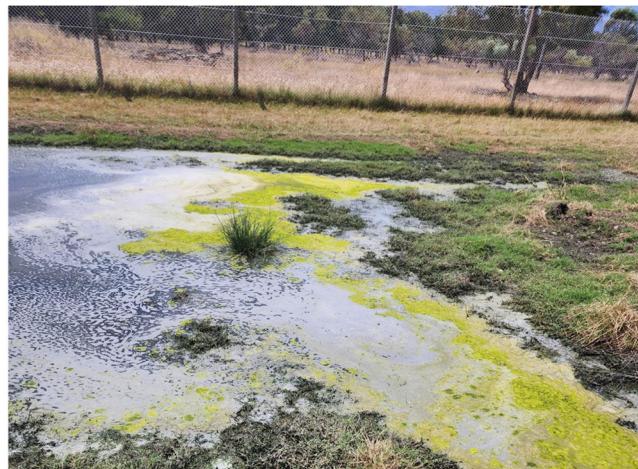
GROUNDWATER RESOURCES LOCATED AND ASSESSED IN THE HYDROCENSUS	
Resource ID	KFBH83E
Latitude	-34.075989
Longitude	18.810791
Resource Type	Borehole
NGA/GRIP No	-
Sample No.	-
Current Use	Not In use
Depth to GW (mbgl)	3.24
Final Depth (mbgl)	3.77
BH Diameter (mm)	130
Casing Diameter (mm)	170
Casing Revealed (cm)	0
Comments	Sustainable yield unknown. Dried up after 15 L of water was removed with bailer and did not recover. Poorly maintained.
Resource ID	Polluted surface water
Latitude	-34.063293
Longitude	18.797981
Resource Type	Surface water
NGA/GRIP No	-
Sample No.	-
Current Use	Not In use
Depth to GW (mbgl)	N/A
Final Depth (mbgl)	N/A
BH Diameter (mm)	N/A
Casing Diameter (mm)	N/A
Casing Revealed (cm)	-
Comments	Water body was observed near the northern boundary of the site. Algal blooms observed within the water with a high dissolved oxygen concentration.
